**HOUSATONIC RIVER BASIN
SEYMOUR, CONNECTICUT**

**MIDDLE RESERVOIR DAM
CT 00590**

**PHASE 1 INSPECTION REPORT
NATIONAL DAM INSPECTION PROGRAM**

APRIL, 1980

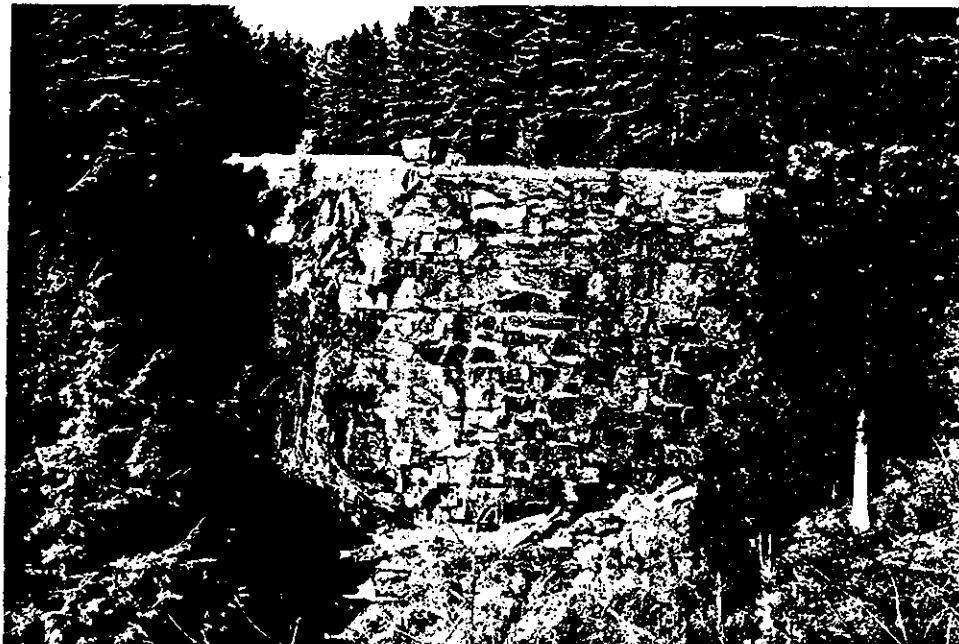
1. **Primary Spillway:** The primary spillway is a 29 foot long and 8 foot wide broad crested weir located in the central portion of the dam (Photo C-1, C-2). It is constructed of a concrete cap over stone masonry, and is also chipped and spalled (Photos C-3 and C-4). Water was not flowing over this spillway at the time of the inspection.

C-2 SPILLWAY AND DOWNSTREAM FACE OF DAM -
LOOKING NORTH

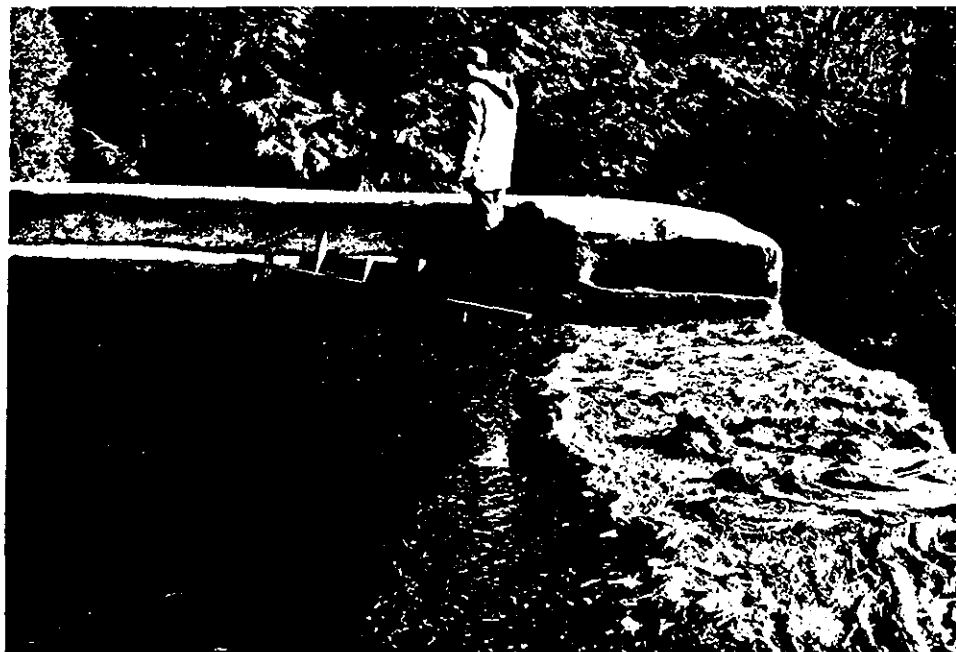
C-4 TOP OF DAM AND SPILLWAY - LOOKING EAST

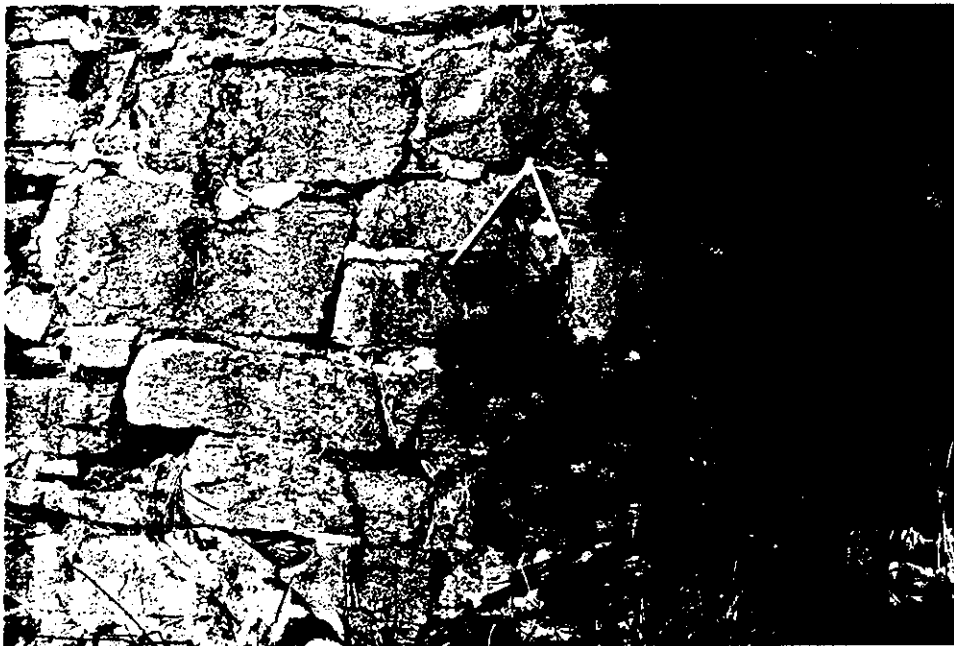
The presence of leakage and vegetative growth on the downstream face and embankment.

C-7 SEEPAGE THROUGH DOWNSTREAM FACE OF DAM

3. The seepage on the downstream face should be monitored to note any change from the existing conditions.
4. Insure the operability of all valves for the outlet works.
5. The cracks in the concrete on the gate house should be repaired.
6. Develop a downstream warning and surveillance plan, including round-the-clock monitoring during heavy precipitation.
7. Institute a program of annual periodic technical inspection.

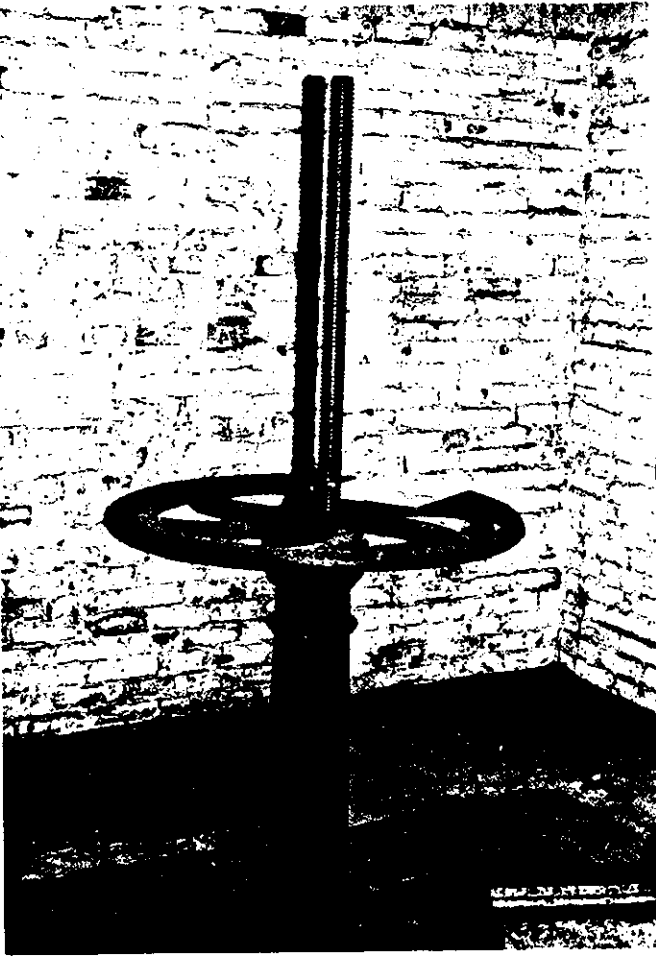
No regular maintenance of the gate house valves was reported. The lift mechanisms appear in good working condition. The control hydrant used to discharge water from the 8 inch blowoff is operated on an annual basis.

C-11 LIFT MECHANISM FOR
30 INCH GATE VALVE -
INSIDE GATE HOUSE

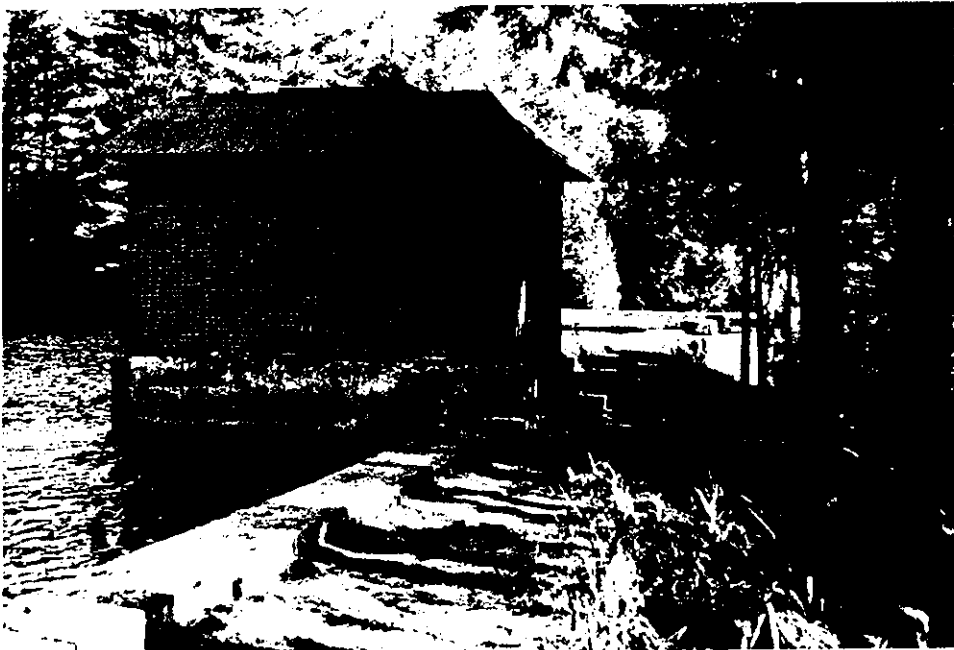
2. **Upstream Face:** The upstream face of the dam is stepped concrete over the original masonry. The face above the water level on the day of the inspection, 12 inches below the dam's west crest, is also spalled and chipped.
3. **Downstream Face:** The downstream face is stone masonry with a slope varying from 1H:5V to 1H:7V. See Appendix B for sections through the dam. Considerable vegetative growth exists on the face including grass, vines and small shrubs (Photo C-1, C-2, C-9). Mortar is missing from most of the joints creating voids and there is leakage from several joints (Photo C-7) and from the ground at the toe (Photo C-8). Trees are growing on the earthen embankment below the western side of the dam (Photo C-12).

6. **Gate House:** The gate house is a brick and concrete structure and is located on the dam's west crest (Photo C-12). The house is generally in good condition with a few minor cracks in the concrete. A single 30 inch pipe admits water into the wet well and is controlled by a 30 inch gate valve which is reportedly operational (Photo C-11).
- d. **Reservoir Area:** The reservoir is formed by the flooding of a portion of the Beaver Brook Valley. The sides of the forested valley have gentle slopes bordering the reservoir. No geologic features were detected that could be expected to adversely affect the dam or its appurtenant structures.

C-12 GATE HOUSE

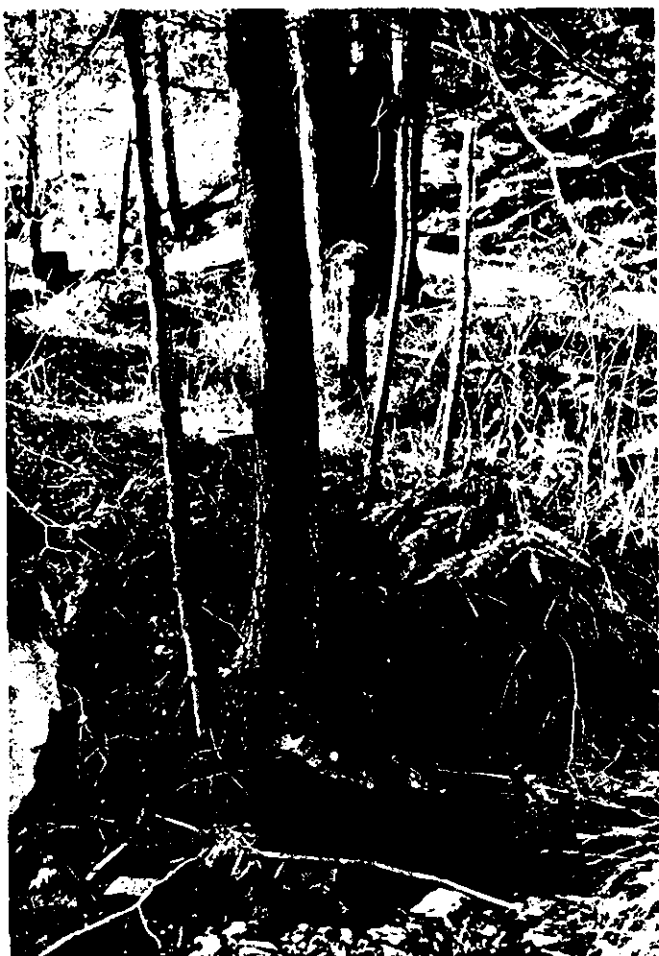
C-13 CONTROL HYDRANT AND
8 INCH BLOWOFF
